Maintenance Evaluation and Program Review 2014-2015

Draft Report

October 2015

AUTORIDAD DE CARRETERAS Y TRANSPORTACION

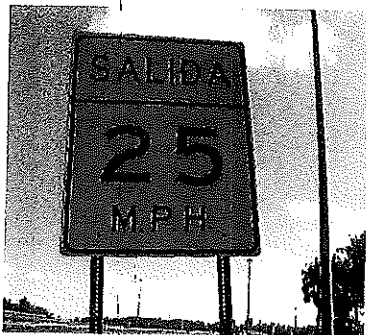
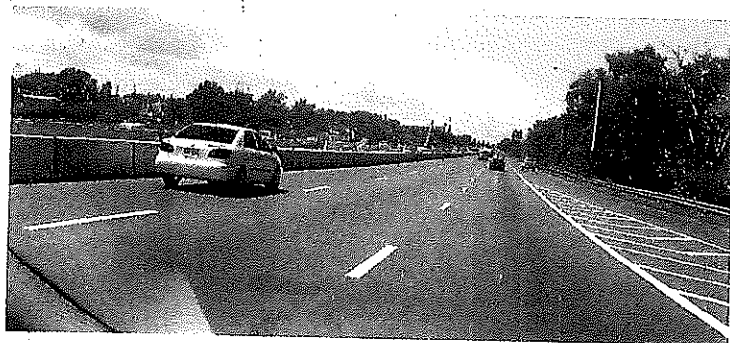
- **Good:** Current minimum condition is satisfactory with only continued normal maintenance required. Under normal circumstances, major repair work should not be required within the next three-five years. Below are two photographs showing an example of a good sign and a good pavement.

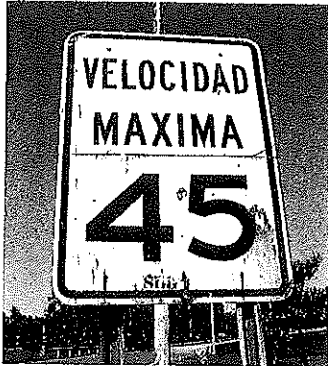
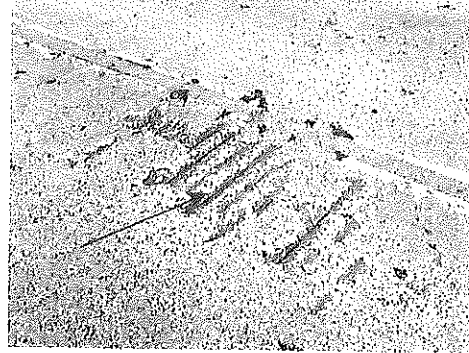
- **Fair:** Current condition of the feature is acceptable. However, some additional maintenance attention is needed to restore the feature to Good condition. In some places, "spot improvements" may be needed to restore the feature to a Good condition. The photos below show examples of "Fair" sign and pavement and conditions. In these cases the sign should be replaced because it has lost its reflectivity and has stains and stickers on its face. The repair for the exposed rebar on the pavement should be a thin overlay until such time as the deck can be completely resurfaced.

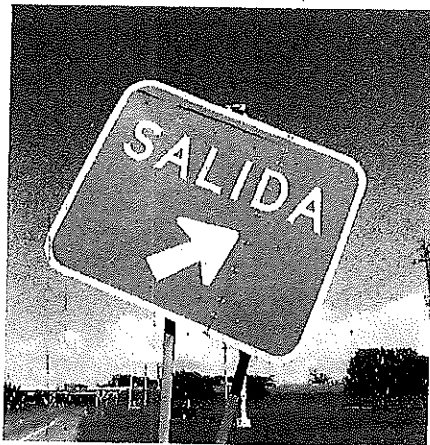
- **Poor:** Current condition is unsatisfactory and maintenance effort must be substantially increased. For some features, major repairs or rehabilitation will be needed to restore the feature to Good condition, or where a significant percentage of the feature is rated as Poor, reconstruction should be considered. Below are two photographs showing a sign and a pavement section in poor condition.

The sign has been hit by a vehicle and the base is damaged as well as the upper left hand portion of the sign. Although the face of the sign is in fair condition, the upper portion is bent and damaged. The repair to this asset should be total replacement including the posts as it could be a liability in any future accident. The failure of the roadway in the picture on the right was caused by a subsurface failure about five years ago. This area has been repaired and is now been restored to good condition.
